Rushford Flood Protection System City Council Project Update

Rushford Flood Protection System

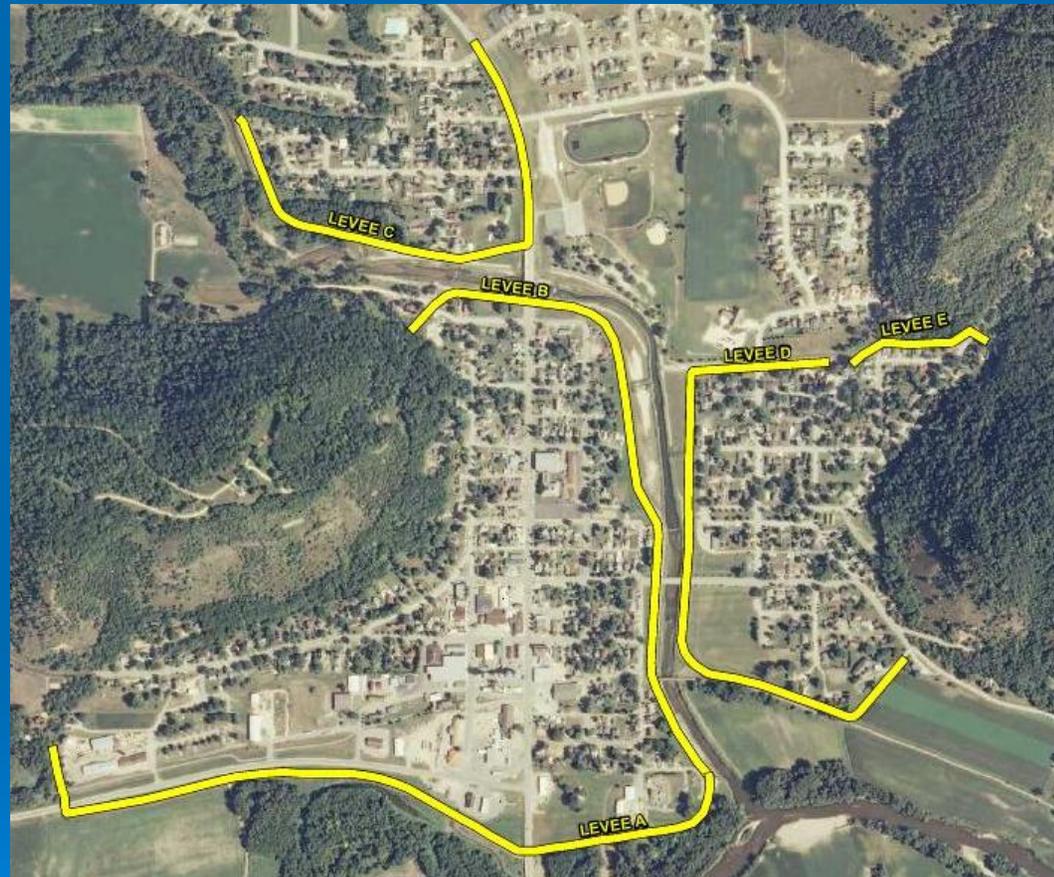
- Three levee systems
- Drainage system w/ closures
- Two pump stations
- Interior flood storage
- Rush Creek channel

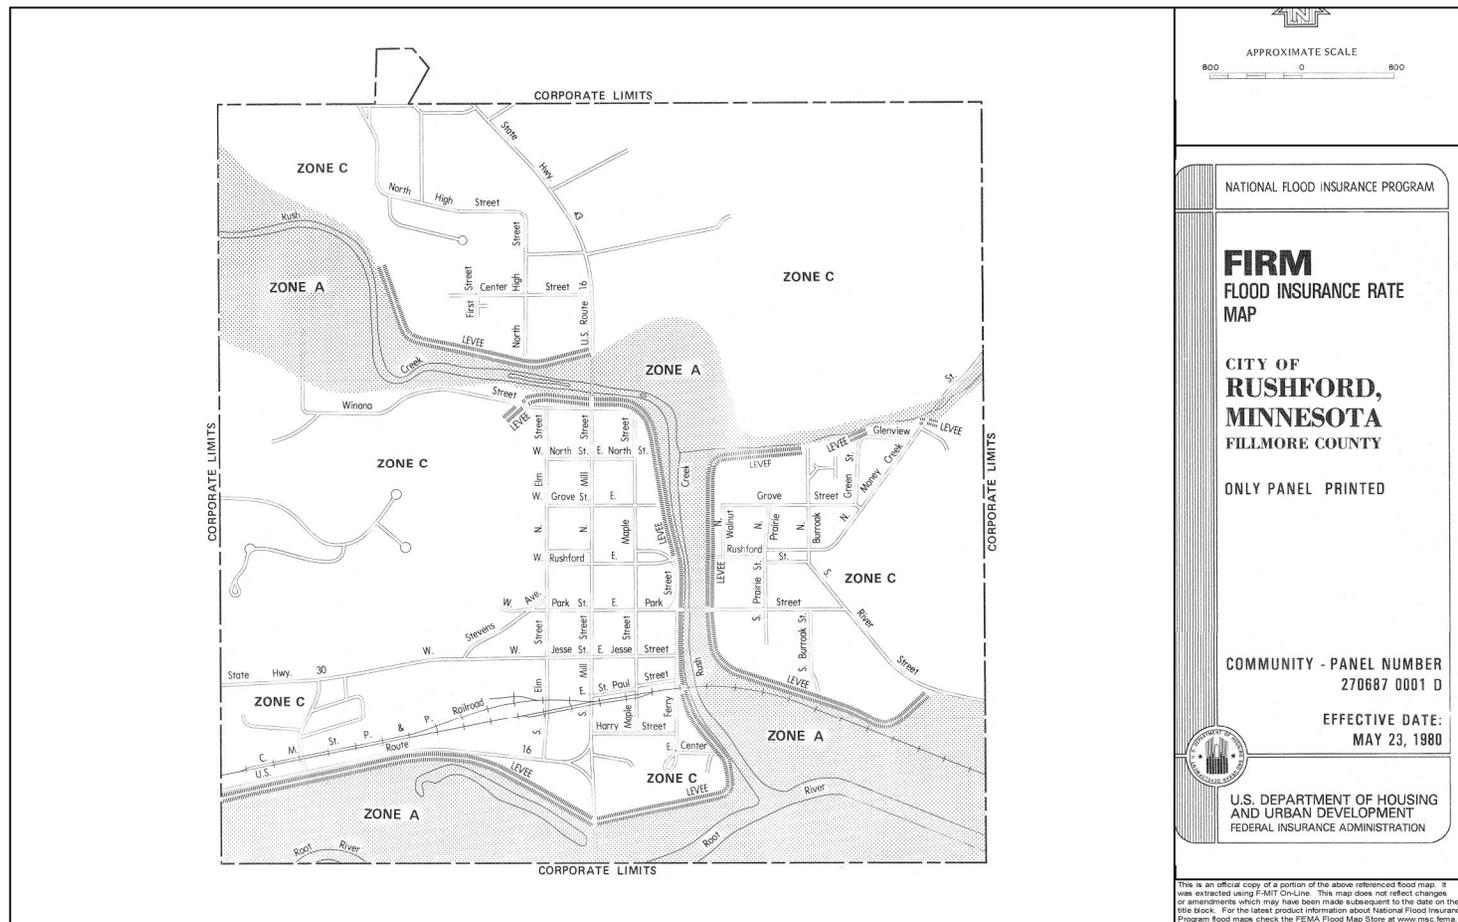
➤ FEMA Floodplain Maps of Rushford

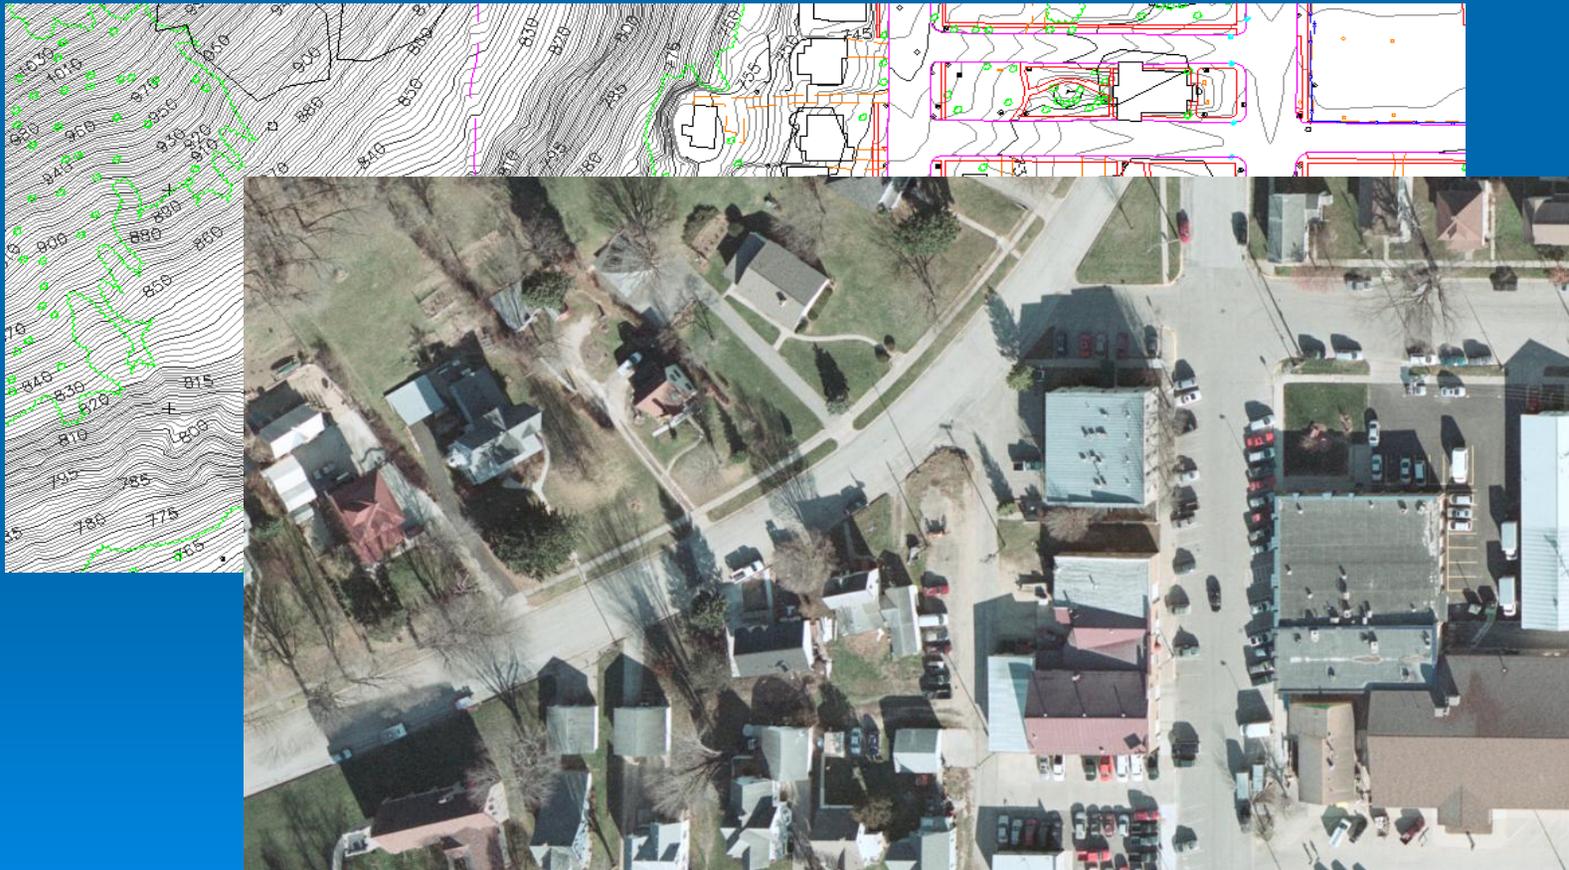
- New topographic map and aerial photo

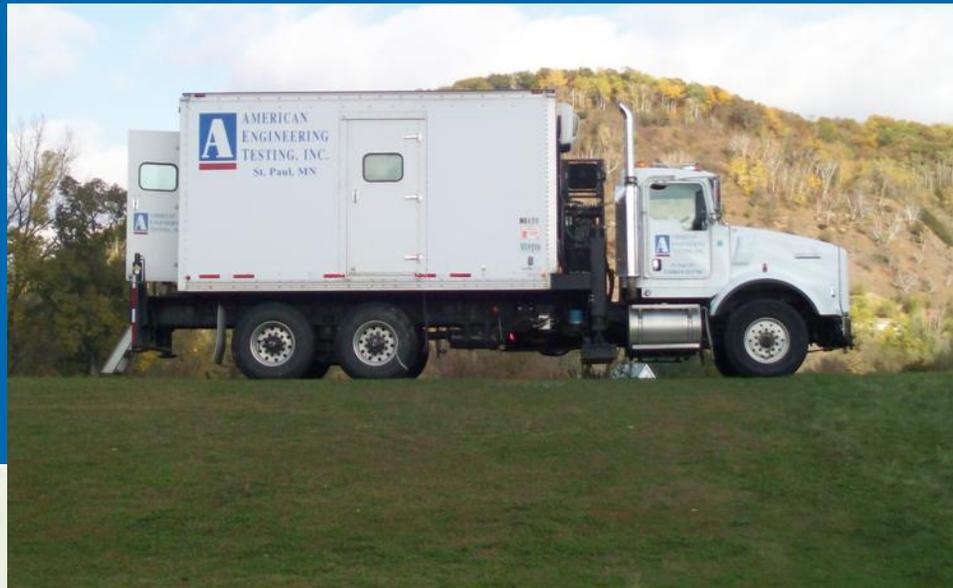
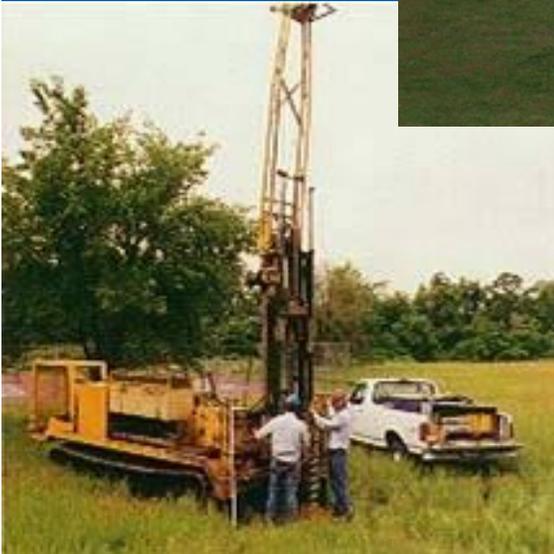
➤ Soil Borings and Testing

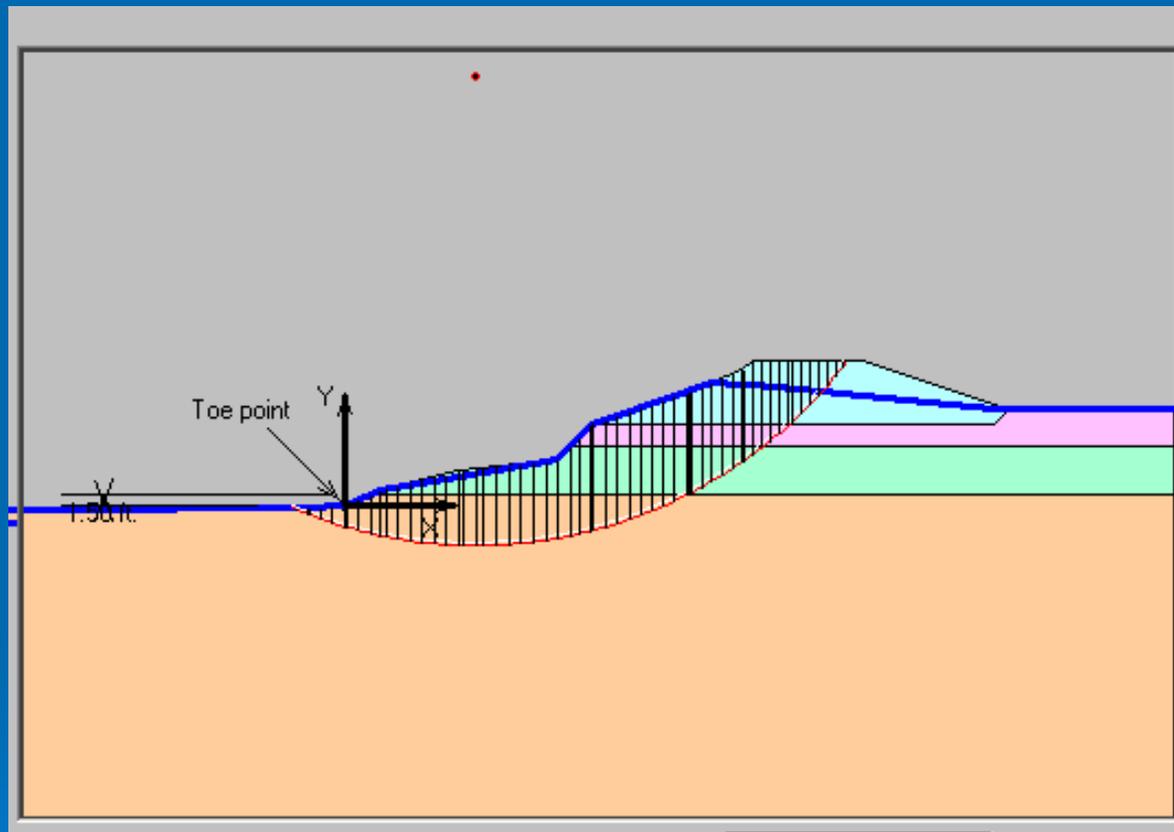
Levee Slope Stability Analysis

Factor of Safety is Acceptable

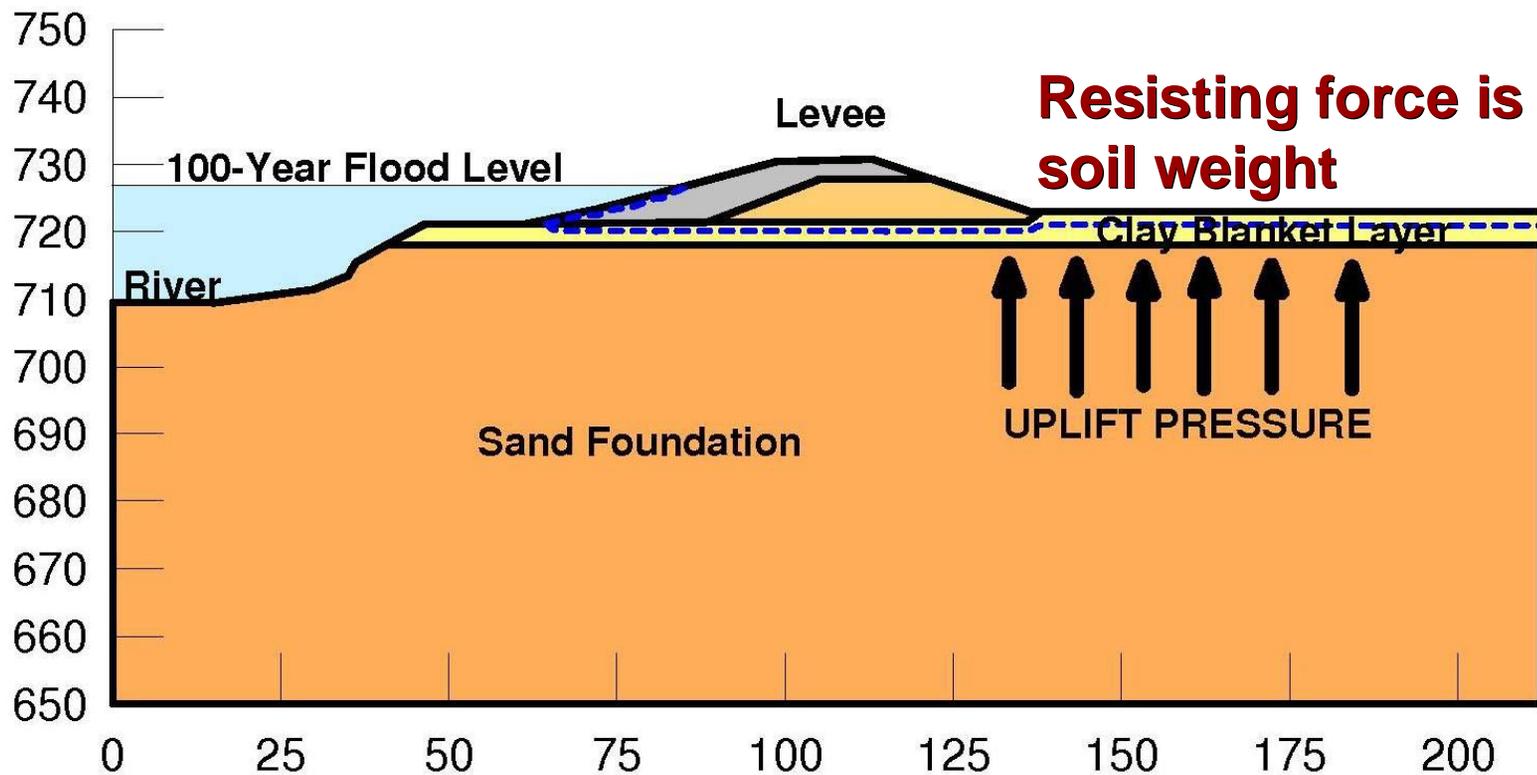
Seepage/Uplift during Flood

- Seepage/uplift at landside toe generally does not meet FEMA standards
- No areas shown to be in failure condition
- Required criteria include a margin of safety, so not meeting FEMA standard is different from being “unsafe”
- Corrective measures needed to improve seepage conditions for levees and meet FEMA standards

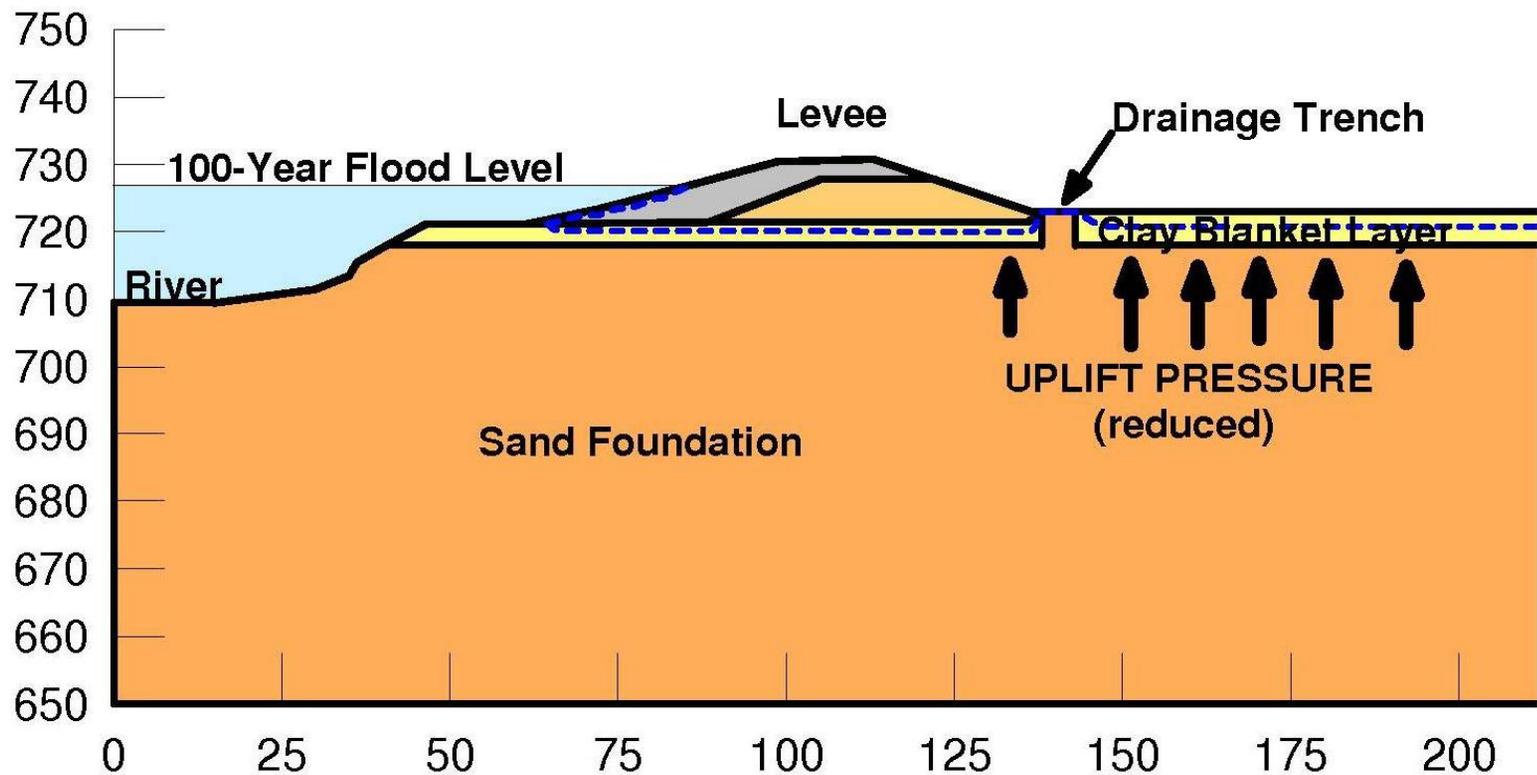
Proposed Solution to Meet Seepage Criteria

- Basements may still be subject to seepage and groundwater flooding after corrective measures
- The evaluation of the interior drainage system should consider the seepage
- Additional soil borings are needed to confirm evaluation and design system

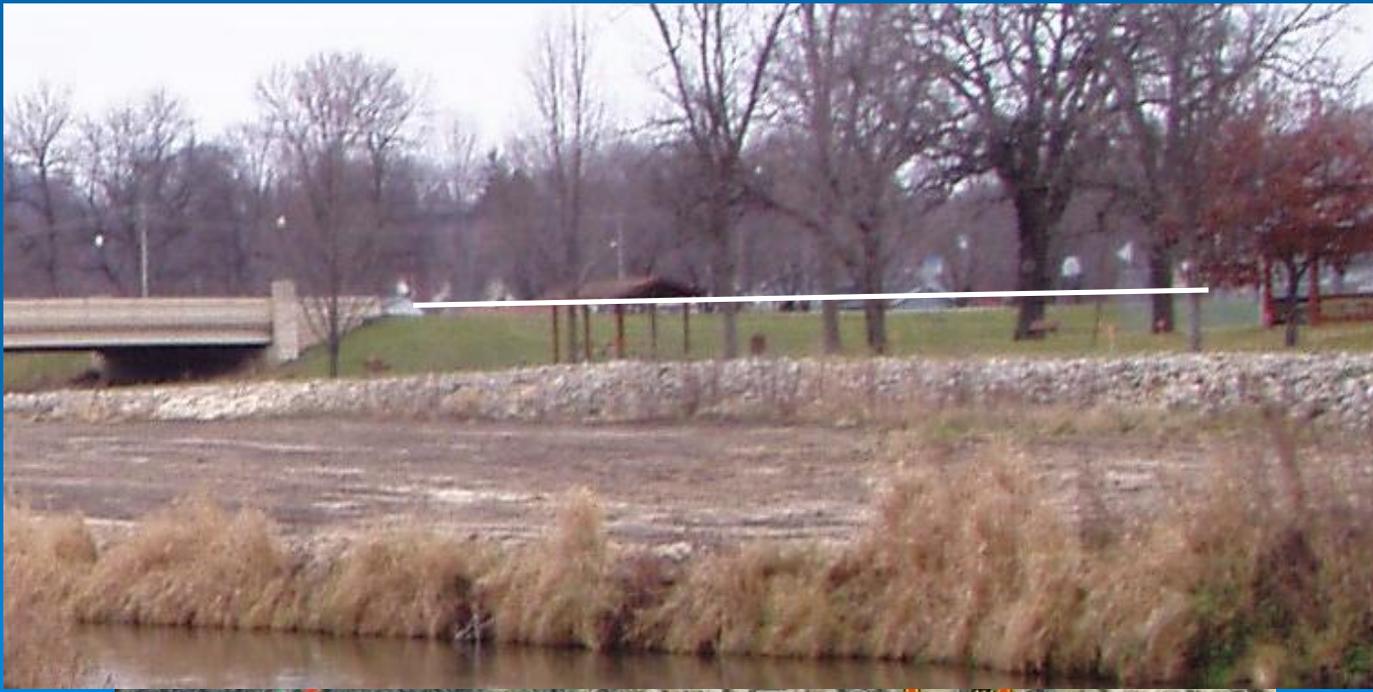
Study Findings – Freeboard

- Highway 43 north of Rush Creek is a part of the levee system.
- Approximately 800 feet of the roadway is too low to meet FEMA freeboard standards

- Work with Mn/DOT to raise Highway 43
- Keep doing Operation and Maintenance
- Consider portable pump system
 - replace pump damaged in 2007 flood
 - help reduce interior drainage flood levels
 - provide backup pump capacity during power outages

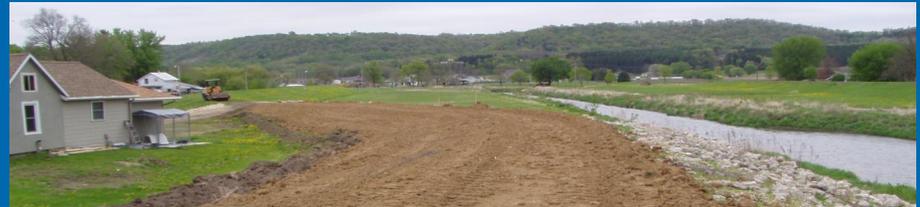
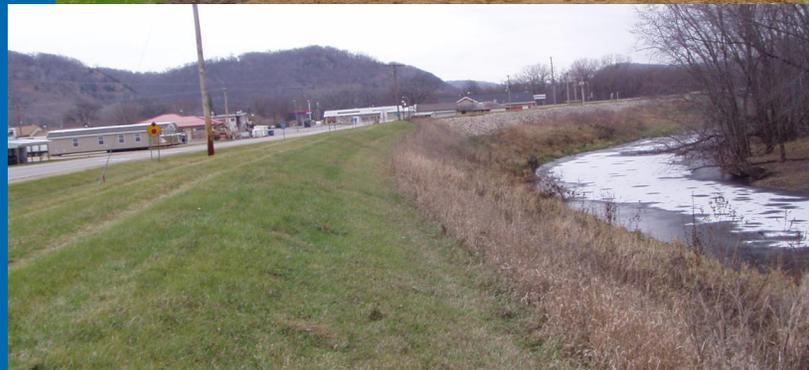
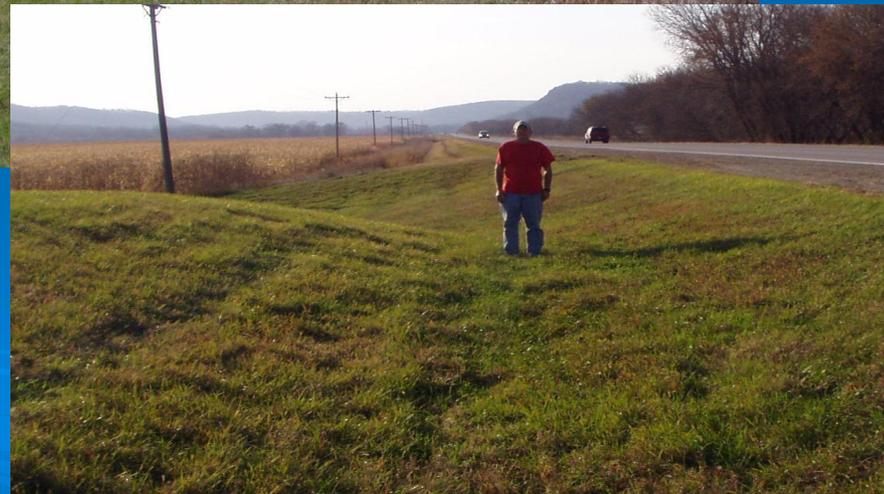
Study Findings – Freeboard

- Part of Rush Creek levee is being raised by Corps of Engineers
- Root River Levee meets freeboard standards
- Highway 16 ditch towards Lanesboro requires sandbagging

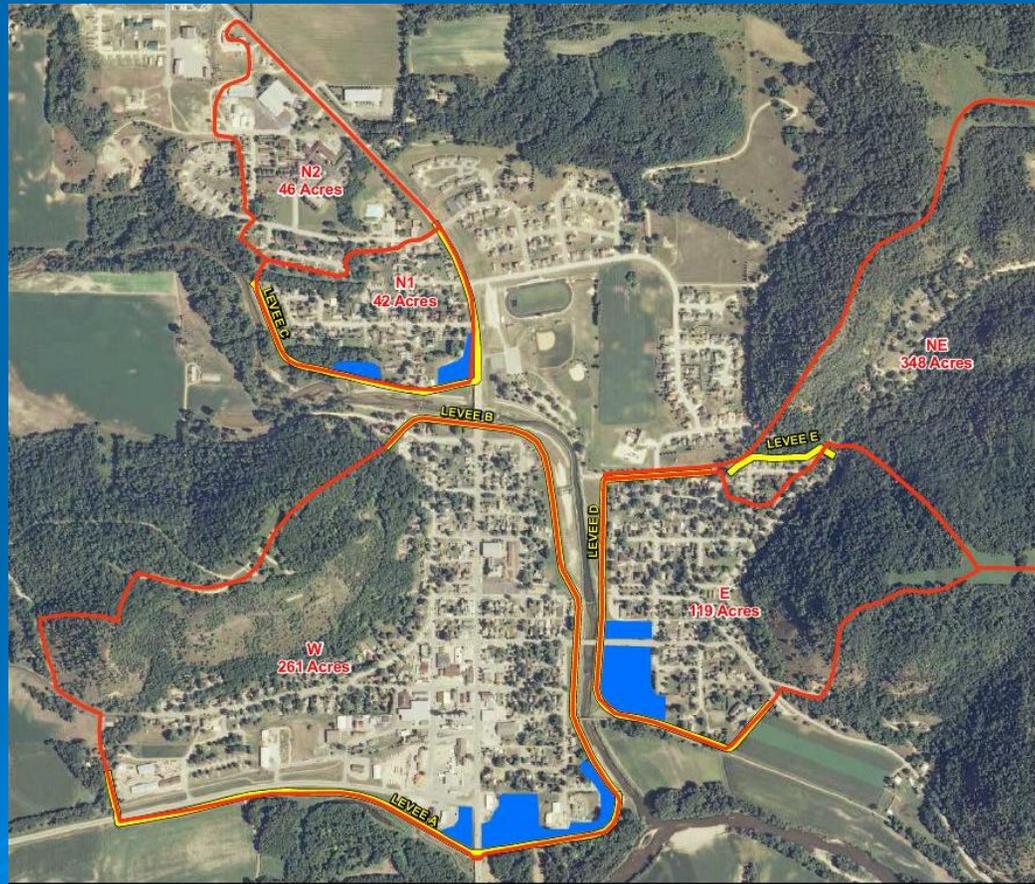
Study Findings – Interior Drainage

- Evaluation of interior flooding is ongoing
- Considers seepage and rainfall
- Maps of each interior area will be prepared

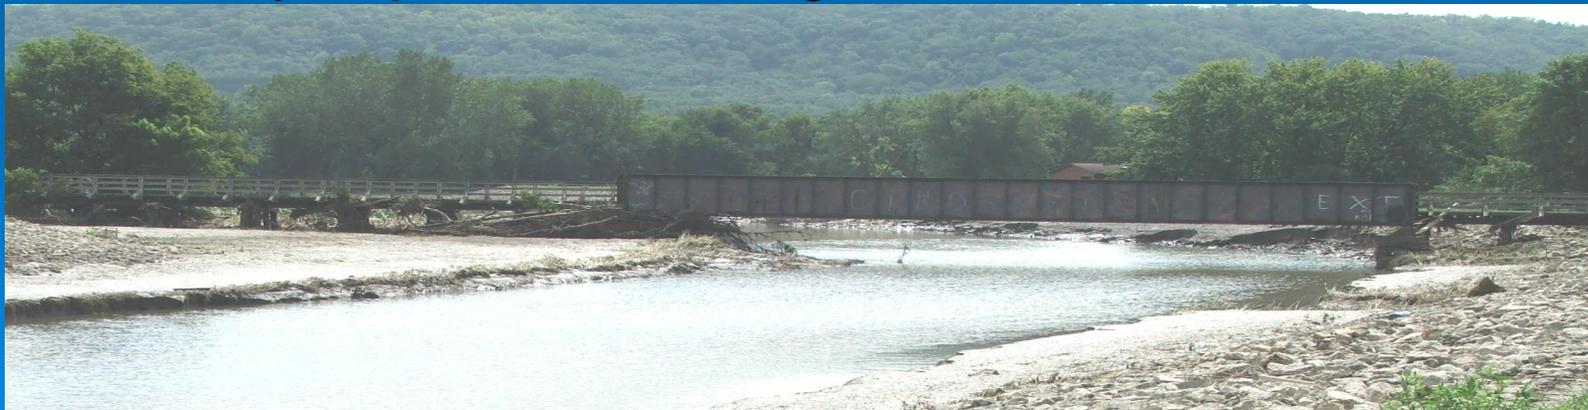
Study Findings – DNR Trail Bridge

- Did not cause flooding of Rushford during 2007 (levee would have overtopped without bridge)
- Does not unduly affect flood levels during the 100-year flood
- Withstood 2007 flood with minor abutment erosion
- Documentation of erosion repair
- Possibly explore other long-term solutions with DNR
